**Flood Control Project Maintenance
Levee Inspections**
LMA District Cover Sheet
Spring 2019 Levee Inspection Results

American River Flood Control District

Spring 2019 Levee Inspection Results

Waterway			Bank	Unit Miles
Unit No. 01 Arcade Creek			Left	2.08
	Spring (March - May)	Summer (June - August)	(September - November) Fall	Winter (December - February)
Unit Maintenance Rating (Fall Only)				
Date of Inspection	5/14/2019 - 5/14/2019			
DWR Inspector	Luz Dial			
Accompanied By	Ross Kawamura ARFCD

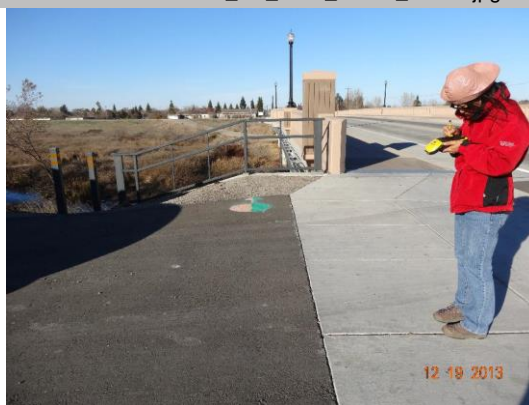
Photo 1 of 1 : UCIP_SP_2019_31169_57044.jpg

LM Start	0.66	Rating **	M	Issue No.	184
LM End	0.66	Issue Type +	En	Location *	
Category	Supplemental			GPS Latitude/Longitude	
				Start	End
Item	DWR UCIP Field Study			38.623668 °	38.623668 °
				-121.457156 °	-121.457156 °
DWR ID	24800				
Comment Code					
Inspector Comment					
FS_ID:31169 DS_ID:24800 EP_NO: N/A Repair Type: Non-Urgent Crossing Status: Found UCIP Comments: Need to coordinate with the City of Sacramento to determine if structure (assumed indicated by green/orange symbol) crosses levee or symbol is referencing bridge. FIELD_STRUCT_DESC: Indicator of crossing found on waterward side edge. Symbol for Flood Control Structure (green/orange circle) was found during field inspection 12/19/13, symbol matches flood control structures that the City of Sacramento inspects. FS Date: 12/19/2013

Indicator of crossing found on waterward side edge. Symbol is a Flood Control Structure (green/orange circle).

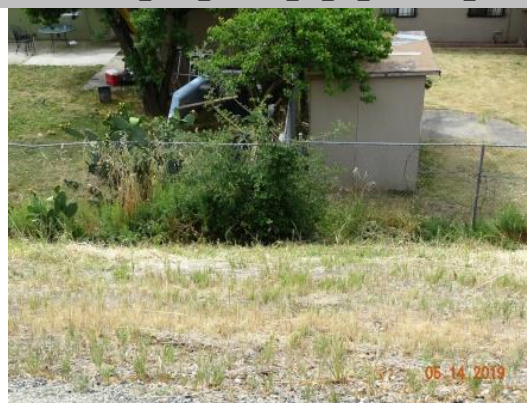
Photo 1 of 1 : SP_2019_NA0001_51_81_20190516_00089.jpg

LM Start	0.74	Rating **	M	Issue No.	81
LM End	0.74	Issue Type +	En	Location *	LS
Category	Earthen Levee			GPS Latitude/Longitude	
				Start	End
Item	Vegetation			38.623932 °	38.623932 °
				-121.455652 °	-121.455652 °
DWR ID	DWR_NA0001_01_s_2019_81				
Comment Code					
V6 : Landscaping					
Inspector Comment					
Remove cactus.

View looking south at cactus on levee toe. Spring 2019

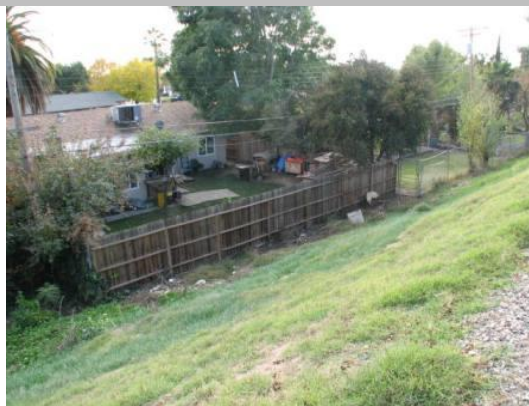
Photo 1 of 1 : SP_2019_NA0001_51_183_20190307_00060.jpg

LM Start	0.77	Rating **	U	Issue No.	183
LM End	0.77	Issue Type +	En	Location *	LS
Category	Earthen Levee			GPS Latitude/Longitude	
				Start	End
Item	Encroachments			38.624016 °	38.624016 °
				-121.455193 °	-121.455193 °
DWR ID	DWR_NA0001_01_s_2012_183				
Comment Code					
FE : Fence					
Inspector Comment					
Dog-eared fence built within 10' of the toe

11/17/2011 Wooden privacy fence.

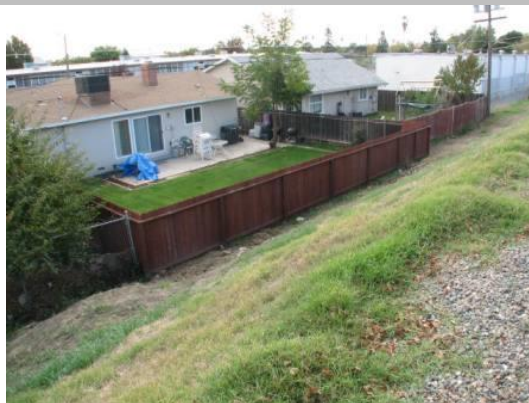
Photo 1 of 1 : SP_2019_NA0001_51_182_20190307_00059.jpg

LM Start	0.95	Rating **	U	Issue No.	182
LM End	0.95	Issue Type +	En	Location *	LS
Category	Earthen Levee			GPS Latitude/Longitude	
				Start	End
Item	Encroachments			38.625072 °	38.625072 °
				-121.452225 °	-121.452225 °
DWR ID	DWR_NA0001_01_s_2012_182				
Comment Code					
FE : Fence					
Inspector Comment					
Dog-eared wooden fence built within 10' of the toe.

11/17/2011 Wooden privacy fence built at the levee toe.

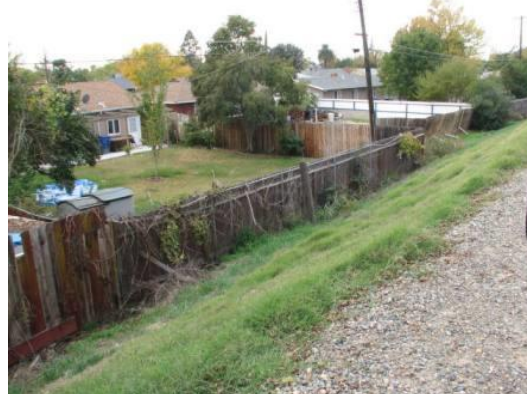
Photo 1 of 1 : SP_2019_NA0001_51_23_20190307_00020.jpg

LM Start	1.15	Rating **	U	Issue No.	23
LM End	1.15	Issue Type +	En	Location *	LS
Category	Earthen Levee			GPS Latitude/Longitude	
				Start	End
Item	Encroachments			38.624871 °	38.624871 °
				-121.448624 °	-121.448624 °
DWR ID	DWR_NA0001_01_s_2012_23				
Comment Code					
FE : Fence					
Inspector Comment					
Dog-eared wooden fence and chain link fence is built against the levee slope.

11/17/2011 Fence built on the levee slope.

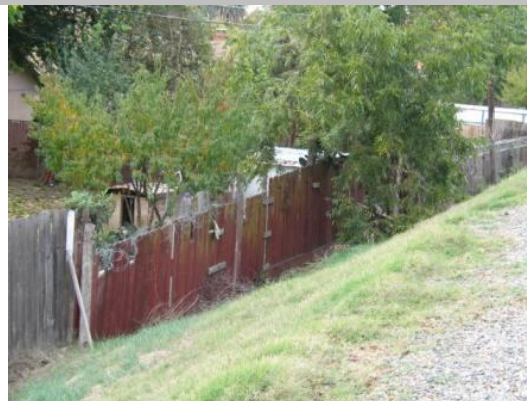
Photo 1 of 1 : SP_2019_NA0001_51_22_20190307_00019.jpg

LM Start	1.15	Rating **	U	Issue No.	22
LM End	1.15	Issue Type +	En	Location *	LS
Category	Earthen Levee			GPS Latitude/Longitude	
				Start	End
Item	Encroachments			38.624879 °	38.624879 °
				-121.448486 °	-121.448486 °
DWR ID	DWR_NA0001_01_s_2012_22				
Comment Code					
FE : Fence					
Inspector Comment					
Dog-eared wooden fence is built against the levee slope.

11/17/2011 Wooden privacy fence built at the levee toe.

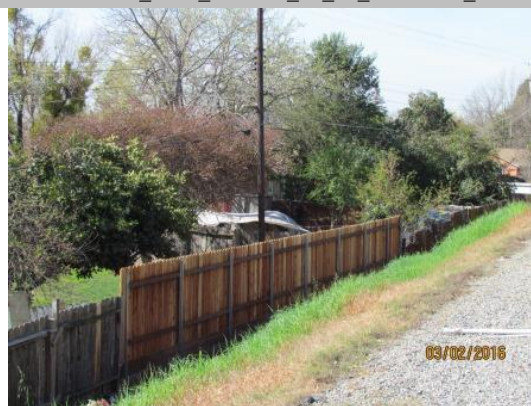
Photo 1 of 1 : SP_2019_NA0001_51_21_20190307_00018.jpg

LM Start	1.17	Rating **	U	Issue No.	21
LM End	1.17	Issue Type +	En	Location *	LS
Category	Earthen Levee			GPS Latitude/Longitude	
				Start	End
Item	Encroachments			38.624906 °	38.624906 °
				-121.448259 °	-121.448259 °
DWR ID	DWR_NA0001_01_s _ 2012_21				
Comment Code					
FE : Fence					
Inspector Comment					
Dog-eared wooden fence is built against the levee slope.

View of the fence at the landside levee toe.

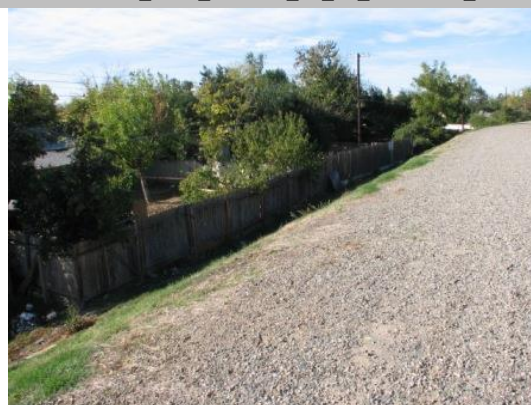
Photo 1 of 1 : SP_2019_NA0001_51_20_20190307_00017.jpg

LM Start	1.18	Rating **	U	Issue No.	20
LM End	1.18	Issue Type +	En	Location *	LS
Category	Earthen Levee			GPS Latitude/Longitude	
				Start	End
Item	Encroachments			38.624900 °	38.624900 °
				-121.448037 °	-121.448037 °
DWR ID	DWR_NA0001_01_s _ 2012_20				
Comment Code					
FE : Fence					
Inspector Comment					
Dog-eared wooden fence is built against the levee slope.

Photo of solid fences built against the levee slope.

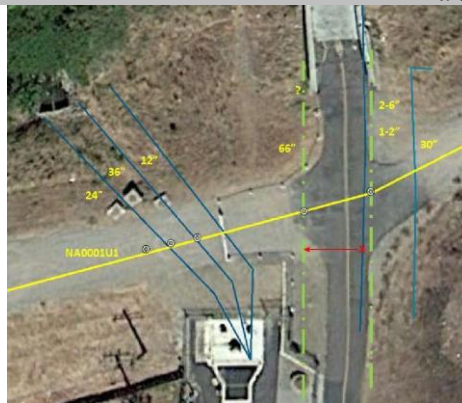
Photo 1 of 1 : UCIP_SP_2019_31178_57059.jpg

Comment Code						
Inspector Comment						
FS_ID:31178 DS_ID:24248 EP_NO: 14575 Repair Type: Non-Urgent Crossing Status: Not Found UCIP Comments: 12/19/2013 Crossing is present in the layer provided by the City of Sacramento, however this crossing was not found in the field. Need to determine status of crossing. If crossing is no longer used, owner will need to coordinate with Central Valley Flood Protection Board to comply with Title 23. FIELD_STRUCT_DESC: 30-inch concrete encased steel water main through the levee, 4.5 feet below the crown. Steel cutoff wall around pipe at center of levee. (30-inch pipe authorized under Permit No. 14575, 1988 - City of Sacramento; 30-inch is scheduled to be cut and replaced under Permit No. 14575-1, 2016 - City of Sacramento) [Additional Reference(s): DWR Levee Log, 2002] FS Date: 12/19/2013

Alignment indicated in blue is approximate locations for pipes that cross levee. Alignment information was obtained from the City of Sacramento.

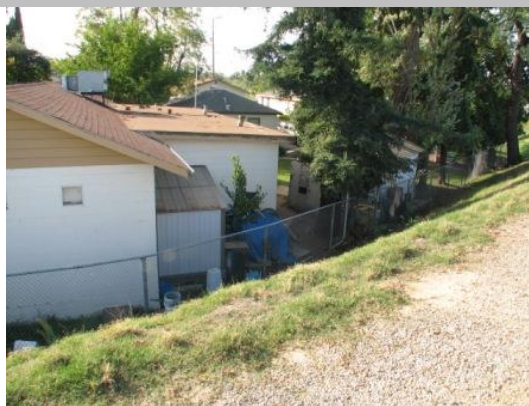
Photo 1 of 1 : SP_2019_NA0001_51_18_20190307_00016.jpg

LM Start	1.26	Rating **	U	Issue No.	18
LM End	1.26	Issue Type +	En	Location *	LS
Category	Earthen Levee			GPS Latitude/Longitude	
				Start	End
Item	Encroachments			38.625395 °	38.625395 °
				-121.446608 °	-121.446608 °
DWR ID	DWR_NA0001_01_s_2012_18				
Comment Code					
BU : Building					
Inspector Comment					
Cement block building within 10-ft of toe. Storage of equipment and supplies blocking visibility.

Fall 2009 photo: Buildings and fence near levee toe.

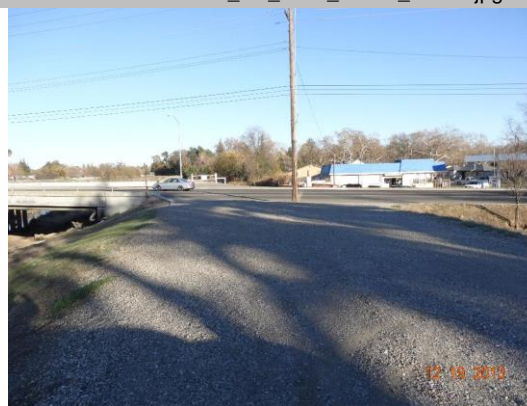
Photo 1 of 3 : UCIP_SP_2019_30085_55489.jpg

LM Start	1.28	Rating **	M	Issue No.	187
LM End	1.28	Issue Type +	En	Location *	
Category	Supplemental			GPS Latitude/Longitude	
				Start	End
Item	DWR UCIP Field Study			38.625500 °	38.625500 °
				-121.446390 °	-121.446390 °
DWR ID	24576				
Comment Code					
Inspector Comment					
FS_ID:30085					
DS_ID:24576					
EP_NO: N/A					
Repair Type: Non-Urgent					
Crossing Status: Indicator Found					
UCIP Comments: Unable to confirm location--will need to coordinate with owner to determine if crossing is still active and determine location.					
FIELD_STRUCT_DESC: 1 of 3: 16-inch pipe through the levee, 8 feet below the crown. Floodgates within the levee across the channel, installed under Permit No. 14480 (1986). [Additional Reference(s):					
DWR Levee Log, 2002]					
FS Date: 12/19/2013

Overview of levee crown at crossing.

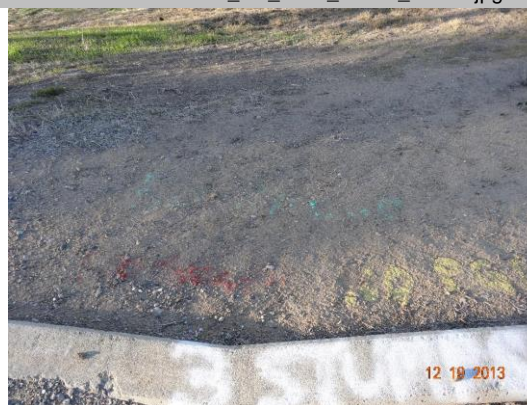
Photo 2 of 3 : UCIP_SP_2019_30085_55488.jpg

Underground service alert (USA) paint markings visible on waterward slope.

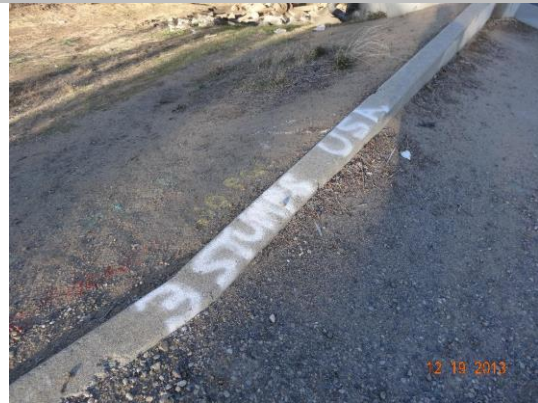
Photo 3 of 3 : UCIP_SP_2019_30085_55490.jpg

LM Start	1.28	Rating **	M	Issue No.	187 (cont)	
LM End	1.28	Issue Type +	En	Location *		
Category	Supplemental			GPS Latitude/Longitude		
				Start	End	
Item	DWR UCIP Field Study			38.625500 °	38.625500 °	
				-121.446390 °	-121.446390 °	
DWR ID	24576					
Comment Code						
Inspector Comment						
FS_ID:30085 DS_ID:24576 EP_NO: N/A Repair Type: Non-Urgent Crossing Status: Indicator Found UCIP Comments: Unable to confirm location--will need to coordinate with owner to determine if crossing is still active and determine location. FIELD_STRUCT_DESC: 1 of 3: 16-inch pipe through the levee, 8 feet below the crown. Floodgates within the levee across the channel, installed under Permit No. 14480 (1986). [Additional Reference(s): DWR Levee Log, 2002] FS Date: 12/19/2013

Concrete floodwall along waterward shoulder.

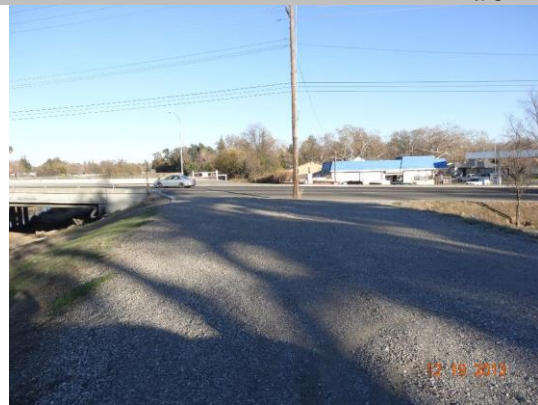
Photo 1 of 3 : UCIP_SP_2019_29732_54976.jpg

LM Start	1.28	Rating **	M	Issue No.	188	
LM End	1.28	Issue Type +	En	Location *		
Category	Supplemental			GPS Latitude/Longitude		
				Start	End	
Item	DWR UCIP Field Study			38.625500 °	38.625500 °	
				-121.446390 °	-121.446390 °	
DWR ID	24577					
Comment Code						
Inspector Comment						
FS_ID:29732						
DS_ID:24577						
EP_NO: N/A						
Repair Type: Non-Urgent						
Crossing Status: Indicator Found						
UCIP Comments: Unable to confirm location--will need to coordinate with owner to determine if crossing is still active and determine location.						
FIELD_STRUCT_DESC: 2 of 3: 6-inch pipe through the levee, 8 feet below the crown. Flap gate on the waterside (WS) end. Floodgates within the levee across the channel, installed under Permit No. 14480 (1986). [Additional Reference(s): DWR Levee Log, 2002]						
FS Date: 12/19/2013

Overview of levee crown.

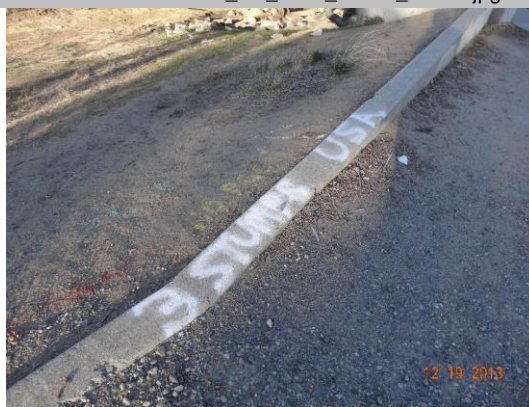
Photo 3 of 3 : UCIP_SP_2019_29732_54977.jpg

LM Start	1.28	Rating **	M	Issue No.	188 (cont)
LM End	1.28	Issue Type +	En	Location *

Floodwall visible along waterward shoulder.

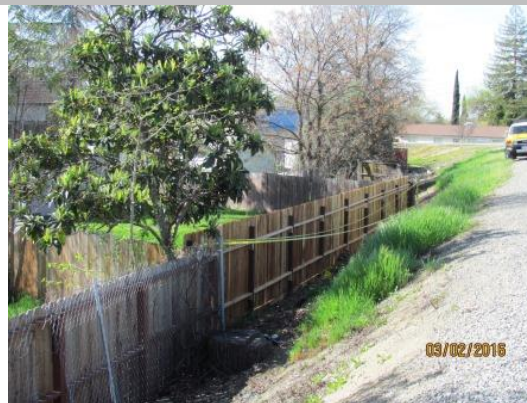
Photo 1 of 1 : SP_2019_NA0001_51_73_20190307_00047.jpg

LM Start	1.33	Rating **	U	Issue No.	73
LM End	1.33	Issue Type +	En	Location *	LS
Category	Earthen Levee			GPS Latitude/Longitude	
				Start	End
Item	Encroachments			38.625869 °	38.625869 °
				-121.445477 °	-121.445477 °
DWR ID	DWR_NA0001_01_f_2015_73				
Comment Code					
FE : Fence					
Inspector Comment					
Fence at LS toe.

View of the fence at the landside levee toe.

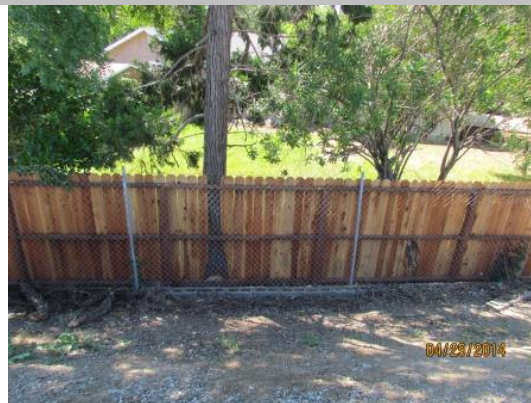
Photo 1 of 1 : SP_2019_NA0001_51_50_20190307_00032.jpg

LM Start	1.35	Rating **	U	Issue No.	50
LM End	1.35	Issue Type +	En	Location *	LS
Category	Earthen Levee			GPS Latitude/Longitude	
				Start	End
Item	Encroachments			38.625982 °	38.625982 °
				-121.445231 °	-121.445231 °
DWR ID	DWR_NA0001_01_s _ 2014_50				
Comment Code					
FE : Fence					
Inspector Comment

View of the fence at the landside levee toe obstructing visibility and access.

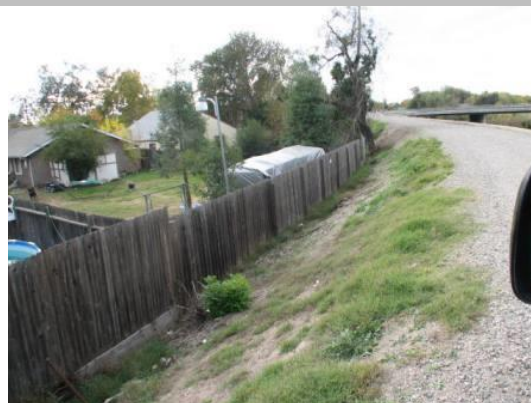
Photo 1 of 1 : SP_2019_NA0001_51_16_20190307_00015.jpg

LM Start	1.36	Rating **	U	Issue No.	16
LM End	1.36	Issue Type +	En	Location *	LS
Category	Earthen Levee			GPS Latitude/Longitude	
				Start	End
Item	Encroachments			38.626000 °	38.626000 °
				-121.444978 °	-121.444978 °
DWR ID	DWR_NA0001_01_s _ 2012_16				
Comment Code					
FE : Fence					
Inspector Comment					
Wooden privacy fence

11/17/2011 Wooden privacy fence built at the levee toe.

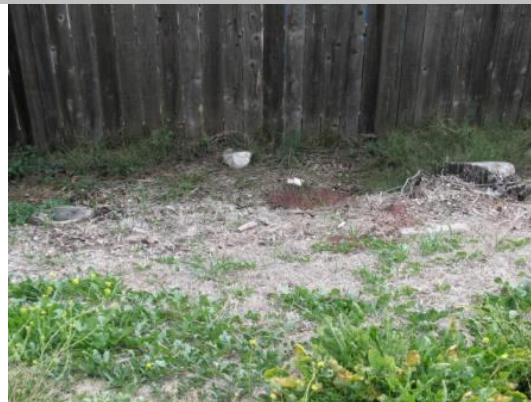
Photo 1 of 1 : SP_2019_NA0001_51_178_20190307_00058.jpg

LM Start	1.36	Rating **	N	Issue No.	178	
LM End	1.36	Issue Type +	Ma	Location *	LS	
Category	Earthen Levee			GPS Latitude/Longitude		
				Start		End
Item	Trim / Thin Trees			38.626063 °		38.626063 °
				-121.444988 °		-121.444988 °
DWR ID	DWR_NA0001_01_s _ 2012_178					
Comment Code						
T5 : Tree stumps.						
Inspector Comment						
Two stumps at landside toe.

11/17/2011 Two stumps at levee toe.

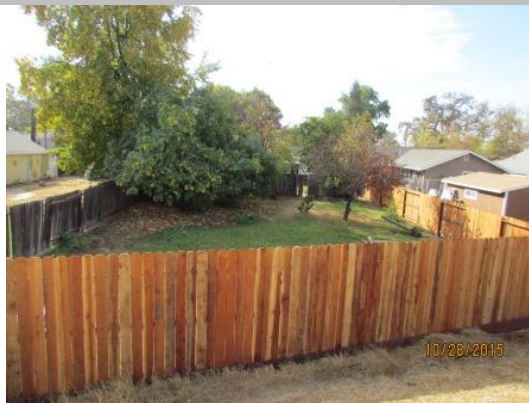
Photo 1 of 1 : SP_2019_NA0001_51_15_20190307_00014.jpg

LM Start	1.37	Rating **	U	Issue No.	15
LM End	1.37	Issue Type +	En	Location *	LS
Category	Earthen Levee			GPS Latitude/Longitude	
				Start	End
Item	Encroachments			38.626048 °	38.626048 °
				-121.444785 °	-121.444785 °
DWR ID	DWR_NA0001_01_s _ 2012_15				
Comment Code					
FE : Fence					
Inspector Comment					
Wooden privacy fence LS toe.

View of the fence at the landside levee toe.

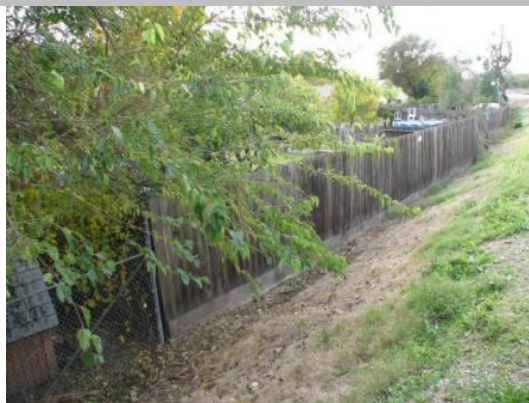
Photo 1 of 1 : SP_2019_NA0001_51_14_20190307_00013.jpg

LM Start	1.38	Rating **	U	Issue No.	14
LM End	1.38	Issue Type +	En	Location *	LS
Category	Earthen Levee			GPS Latitude/Longitude	
				Start	End
Item	Encroachments			38.626085 °	38.626085 °
				-121.444580 °	-121.444580 °
DWR ID	DWR_NA0001_01_s _ 2012_14				
Comment Code					
FE : Fence					
Inspector Comment					
Wooden privacy fence

11/17/2011 Wooden privacy fence built at the levee toe.

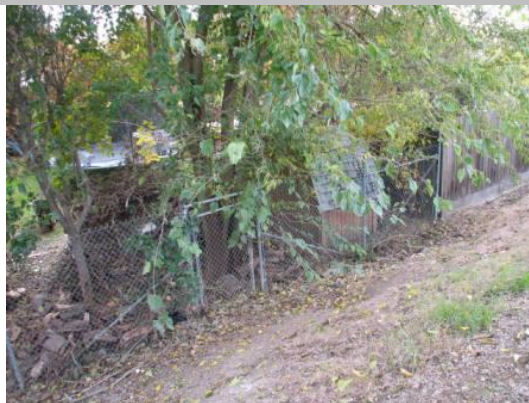
Photo 1 of 1 : SP_2019_NA0001_51_38_20190307_00028.jpg

LM Start	1.40	Rating **	M	Issue No.	38
LM End	1.40	Issue Type +	En	Location *	LS
Category	Earthen Levee			GPS Latitude/Longitude	
				Start	End
Item	Encroachments			38.626210 °	38.626210 °
				-121.444320 °	-121.444320 °
DWR ID	DWR_NA0001_01_s _ 2012_38				
Comment Code					
BU : Building					
Inspector Comment					
Small wooden storage shed and firewood are placed along chain link fence within 10-ft of levee toe.

11/17/2011 Shed and firewood can be seen through the chainlink fence.

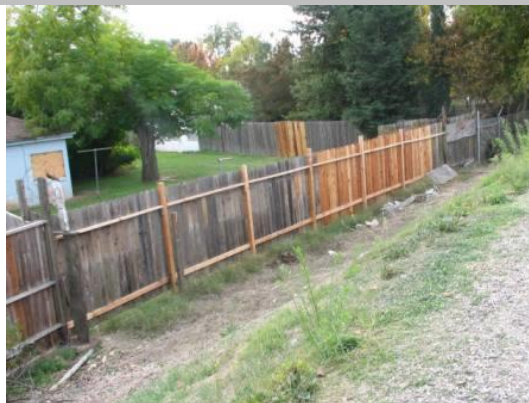
Photo 1 of 1 : SP_2019_NA0001_51_13_20190307_00012.jpg

LM Start	1.40	Rating **	U	Issue No.	13
LM End	1.40	Issue Type +	En	Location *	LS
Category	Earthen Levee			GPS Latitude/Longitude	
				Start	End
Item	Encroachments			38.626155 °	38.626155 °
				-121.444250 °	-121.444250 °
DWR ID	DWR_NA0001_01_s_2012_13				
Comment Code					
FE : Fence					
Inspector Comment					
Wooden fence with barbed wire is built within 10-ft of levee toe.

11/17/2011 New wooden privacy fence built within 15' of the levee toe.

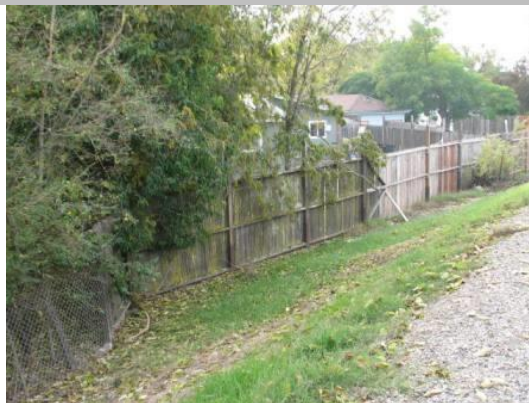
Photo 1 of 1 : SP_2019_NA0001_51_12_20190307_00011.jpg

LM Start	1.41	Rating **	U	Issue No.	12
LM End	1.41	Issue Type +	En	Location *	LS
Category	Earthen Levee			GPS Latitude/Longitude	
				Start	End
Item	Encroachments			38.626212 °	38.626212 °
				-121.444082 °	-121.444082 °
DWR ID	DWR_NA0001_01_s_2012_12				
Comment Code					
FE : Fence					
Inspector Comment					
Dog-eared wooden fence is built near the levee slope.

11/17/2011 Wooden privacy fence built within 15' of the levee toe.

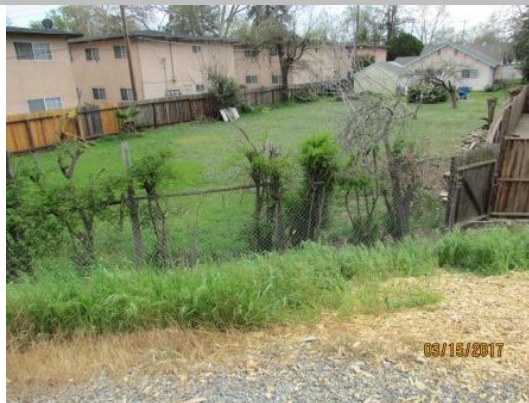
Photo 1 of 2 : SP_2019_NA0001_51_177_20190307_00056.jpg

LM Start	1.42	Rating **	M	Issue No.	177
LM End	1.42	Issue Type +	En	Location *	LS
Category	Earthen Levee			GPS Latitude/Longitude	
				Start	End
Item	Vegetation			38.626388 °	38.626388 °
				-121.443910 °	-121.443910 °
DWR ID	DWR_NA0001_01_s_2012_177				
Comment Code					
V6 : Landscaping					
Inspector Comment

Another view of the vegetation at levee toe. Spring 2017.

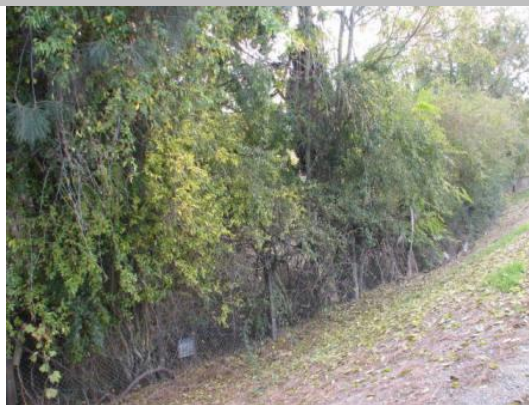
Photo 2 of 2 : SP_2019_NA0001_51_177_20190307_00057.jpg

11/17/2011 Thick vegetation at the levee toe.

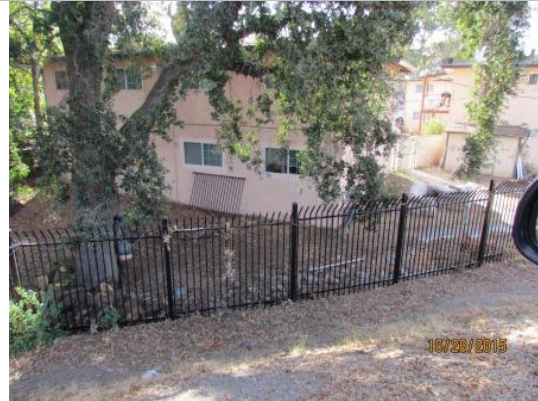
Photo 1 of 1 : SP_2019_NA0001_51_70_20190307_00046.jpg

LM Start	1.44	Rating **	U	Issue No.	70
LM End	1.44	Issue Type +	En	Location *	LS
Category	Earthen Levee			GPS Latitude/Longitude	
				Start	End
Item	Encroachments			38.626589 °	38.626589 °
				-121.443640 °	-121.443640 °
DWR ID	DWR_NA0001_01_f_2015_70				
Comment Code					
FE : Fence					
Inspector Comment					
Wrought iron fence at LS toe blocks access.

View of the fence at the landside levee toe.

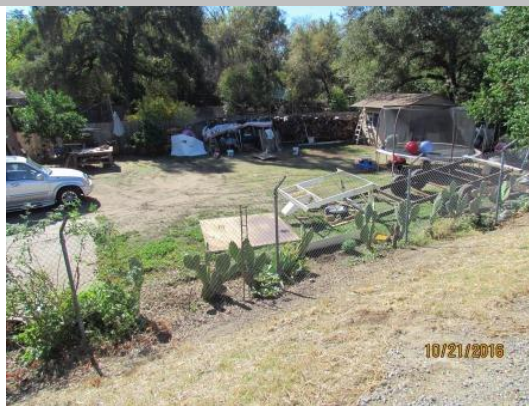
Photo 1 of 1 : SP_2019_NA0001_51_68_20190307_00045.jpg

LM Start	1.54	Rating **	M	Issue No.	68
LM End	1.54	Issue Type +	En	Location *	LS
Category	Earthen Levee			GPS Latitude/Longitude	
				Start	End
Item	Vegetation			38.627283 °	38.627283 °
				-121.442180 °	-121.442180 °
DWR ID	DWR_NA0001_01_f_2015_68				
Comment Code					
V6 : Landscaping					
Inspector Comment					
Cactus planted along LS toe.

View of the landscaping at the landside levee toe.

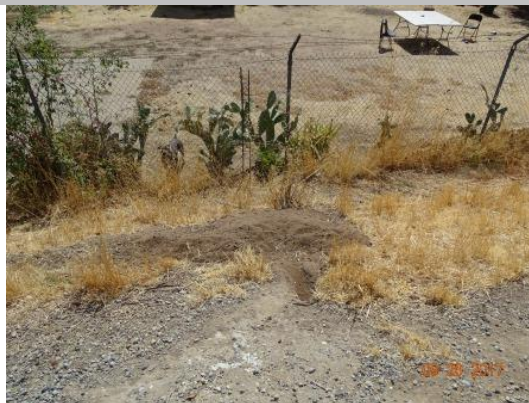
Photo 1 of 1 : SP_2019_NA0001_51_11_20190307_00010.jpg

LM Start	1.54	Rating **	M	Issue No.	11
LM End	1.54	Issue Type +	Ma	Location *	LS
Category	Earthen Levee			GPS Latitude/Longitude	
				Start	End
Item	Animal Control			38.627298 °	38.627298 °
				-121.442131 °	-121.442131 °
DWR ID	DWR_NA0001_01_f_2017_11				
Comment Code					
A3 : No rodents visible, but rodent burrows visible; need to backfill and compact or grout burrows.					
Inspector Comment					
Area shows signs of rodent activity.

View of the rodent activity on the levee slope.

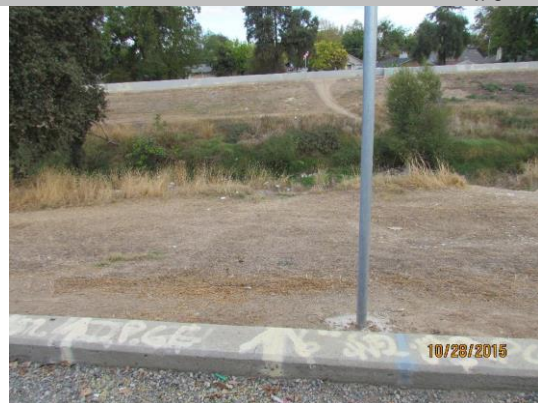
Photo 1 of 3 : UCIP_SP_2019_52671_74731.jpg

Comment Code					
Inspector Comment					
FS_ID:52671 DS_ID:24573 EP_NO: N/A Repair Type: Non-Urgent Crossing Status: Indicator Found UCIP Comments: 08/11/2017 PG&E records for DFM 0614-13 indicate that there were no observations found on the 07/2017 patrol, no leaks found on the 04/2017 leak survey, and the pipeline is operating correctly according to the 11/2016 CP inspection. (DWR UCIP - A. McDonald)11/12/15 Markers have been installed on both levees--confirmed during DWR Fall Inspection. Need to coordinate with PG&E to determine permit for this crossing. (DWR UCIP - O. Magana) 12/19/13 No markers visible indicating crossing through levee. PG&E line. Need to coordinate with owner. Permit? (DWR UCIP - O. Magana) FIELD_STRUCT_DESC: 2 of 2: 6-inch pipe through the levee, at an unknown depth and goes under the channel. In case of an emergency related to this pipeline, PG&E has identified the following contacts: PG&E's local pipeline engineer, Mike Aronoff at 916-307-9472 (cell), and Gas Control (north) at 800-442-4743. For non-emergency issues, please contact the local PG&E Gas Pipeline Operations and Maintenance (GPOM) supervisors for the Sacramento region, David Wade at 209-639-1039 (cell), or Ron Hicks at 916-396-9038 (cell). [Additional Reference(s): DWR Levee Log, 2002] FS Date: 11/12/2015 1:52:00 PM

Markers installed on both levees in 2015.

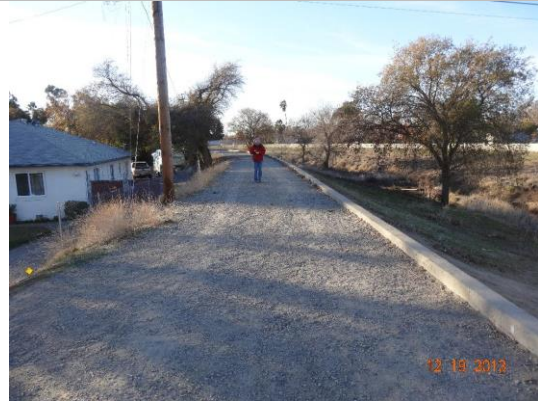
Photo 2 of 3 : UCIP_SP_2019_52671_57072.jpg

Overview of area near crossing. Inspector is standing where crossing goes through levee.

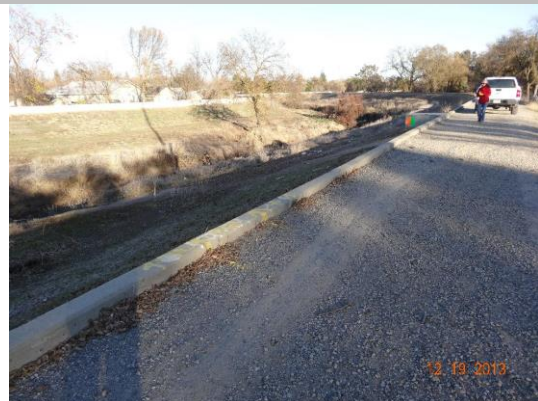
Photo 3 of 3 : UCIP_SP_2019_52671_57071.jpg

View of waterward side.

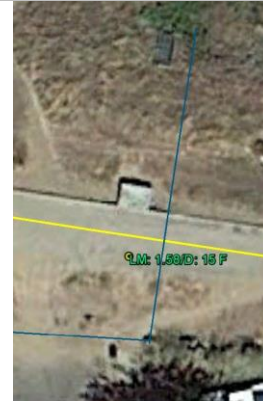
Photo 1 of 3 : UCIP_SP_2019_31182_57075.jpg

Comment Code						
Inspector Comment						
FS_ID:31182 DS_ID:24255 EP_NO: N/A Repair Type: Non-Urgent Crossing Status: Found UCIP Comments: 08/16/2017 DWR Deferred Maintenance Project (DMP), Vince Rodriguez, forwarded email received from Tim Kerr, General Manager of American River Flood Control District (ARFCD) with file "DWR Eligible Pipes Found in ARFCD" from ARFCD that shows the ownership and location of the pipes Tim Kerr investigated. Owner of this crossing is identified as the City of Sacramento, ARFCD Staff Notes indicate Arcade Ck at Belden St. (DWR UCIP - O. Magana) 06/06/2017 Received documentation from the City of Sacramento indicating that this crossing was internally inspected on 11/26/2013, PACP Sewer Report was provided. No additional information was received from the City of Sacramento. Need to request evaluation of pipe (integrity of pipe section through the levee) and clarify pipe size. (DWR UCIP – O. Magana) 01/29/14 approximate alignment of crossings was provided by the City of Sacramento for known crossings through levee. Unable to confirm last inspection. Also City records indicate 24-inch CMP not 15-inch--need to clarify with owner. Crossing is operational. FIELD_STRUCT_DESC: 15-inch drainage pipe of unknown material (City records indicate a 24-inch reinforced concrete pipe (RCP) at this location) through the levee, 8.5 feet below the crown. Flap gate on the waterside (WS) end. (no permit was found authorizing this pipe - the City of Sacramento is the owner of this pipe) [Additional Reference(s): DWR Levee Log, 2002] FS Date: 12/19/2013

Alignment in blue is an estimate of pipe alignment provided by the City of Sacramento. The symbol at LM 1.58 is field confirmed location.

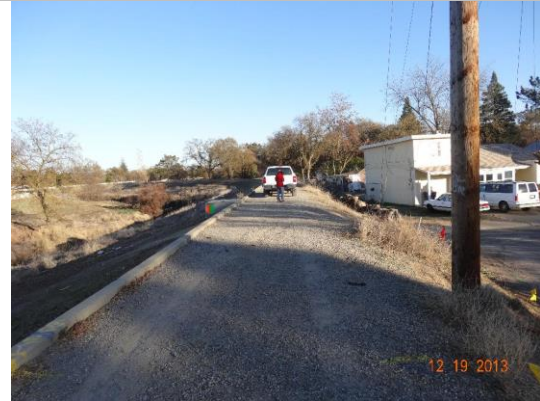
Photo 2 of 3 : UCIP_SP_2019_31182_57076.jpg

Comment Code						
Inspector Comment						
FS_ID:31182 DS_ID:24255 EP_NO: N/A Repair Type: Non-Urgent Crossing Status: Found UCIP Comments: 08/16/2017 DWR Deferred Maintenance Project (DMP), Vince Rodriguez, forwarded email received from Tim Kerr, General Manager of American River Flood Control District (ARFCD) with file "DWR Eligible Pipes Found in ARFCD" from ARFCD that shows the ownership and location of the pipes Tim Kerr investigated. Owner of this crossing is identified as the City of Sacramento, ARFCD Staff Notes indicate Arcade Ck at Belden St. (DWR UCIP - O. Magana) 06/06/2017 Received documentation from the City of Sacramento indicating that this crossing was internally inspected on 11/26/2013, PACP Sewer Report was provided. No additional information was received from the City of Sacramento. Need to request evaluation of pipe (integrity of pipe section through the levee) and clarify pipe size. (DWR UCIP – O. Magana) 01/29/14 approximate alignment of crossings was provided by the City of Sacramento for known crossings through levee. Unable to confirm last inspection. Also City records indicate 24-inch CMP not 15-inch--need to clarify with owner. Crossing is operational. FIELD_STRUCT_DESC: 15-inch drainage pipe of unknown material (City records indicate a 24-inch reinforced concrete pipe (RCP) at this location) through the levee, 8.5 feet below the crown. Flap gate on the waterside (WS) end. (no permit was found authorizing this pipe - the City of Sacramento is the owner of this pipe) [Additional Reference(s): DWR Levee Log, 2002] FS Date: 12/19/2013

Overview of levee at crossing.

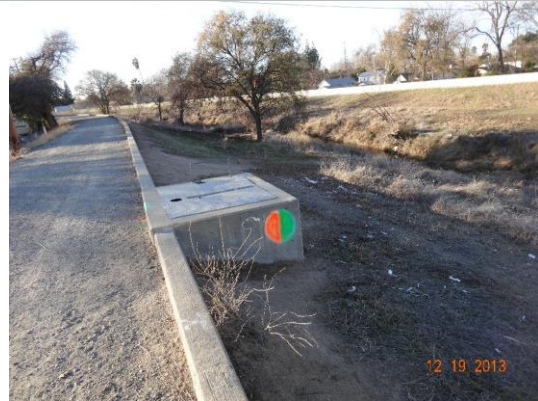
Photo 3 of 3 : UCIP_SP_2019_31182_57077.jpg

FS_ID:31182
DS_ID:24255
EP_NO: N/A
Repair Type: Non-Urgent
Crossing Status: Found
UCIP Comments: 08/16/2017 DWR Deferred Maintenance Project (DMP), Vince Rodriguez, forwarded email received from Tim Kerr, General Manager of American River Flood Control District (ARFCD) with file "DWR Eligible Pipes Found in ARFCD" from ARFCD that shows the ownership and location of the pipes Tim Kerr investigated. Owner of this crossing is identified as the City of Sacramento, ARFCD Staff Notes indicate Arcade Ck at Belden St. (DWR UCIP - O. Magana) 06/06/2017 Received documentation from the City of Sacramento indicating that this crossing was internally inspected on 11/26/2013, PACP Sewer Report was provided. No additional information was received from the City of Sacramento. Need to request evaluation of pipe (integrity of pipe section through the levee) and clarify pipe size. (DWR UCIP - O. Magana)
01/29/14 approximate alignment of crossings was provided by the City of Sacramento for known crossings through levee. Unable to confirm last inspection. Also City records indicate 24-inch CMP not 15-inch--need to clarify with owner. Crossing is operational.

FIELD_STRUCT_DESC: 15-inch drainage pipe of unknown material (City records indicate a 24-inch reinforced concrete pipe (RCP) at this location) through the levee, 8.5 feet below the crown. Flap gate on the waterside (WS) end. (no permit was found authorizing this pipe - the City of Sacramento is the owner of this pipe) [Additional Reference(s): DWR Levee Log, 2002]
FS Date: 12/19/2013

View of concrete vault located on waterward apex.

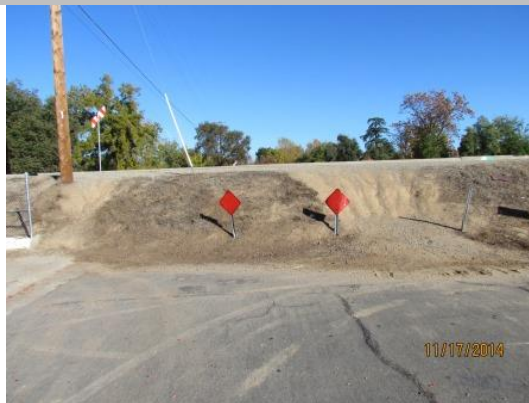
Photo 1 of 1 : SP_2019_NA0001_51_54_20190307_00035.jpg

LM Start	1.58	Rating **	A/W	Issue No.	54
LM End	1.58	Issue Type +	Ma	Location *	LS
Category	Earthen Levee			GPS Latitude/Longitude	
				Start	End
Item	Slope Stability			38.627251 °	38.627251 °
				-121.441460 °	-121.441460 °
DWR ID	DWR_NA0001_01_s_2012_54				
Comment Code					
S2 : Repair the levee slope damaged by foot traffic and prevent access where possible.					
Inspector Comment

Slope stability due to foot traffic needs to be monitored.

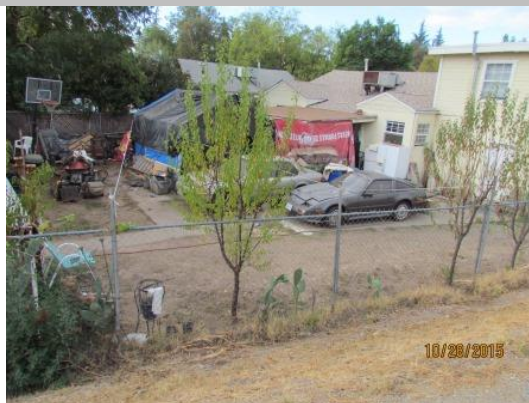
Photo 1 of 1 : SP_2019_NA0001_51_67_20190307_00044.jpg

LM Start	1.60	Rating **	M	Issue No.	67
LM End	1.60	Issue Type +	En	Location *	LS
Category	Earthen Levee			GPS Latitude/Longitude	
				Start	End
Item	Encroachments			38.627207 °	38.627207 °
				-121.441104 °	-121.441104 °
DWR ID	DWR_NA0001_01_f_2015_67				
Comment Code					
FE : Fence					
Inspector Comment					
Fence at landside levee toe. 6 fruit trees and various cactus plants at LS toe.

View of the fence and landscaping at the landside levee toe.

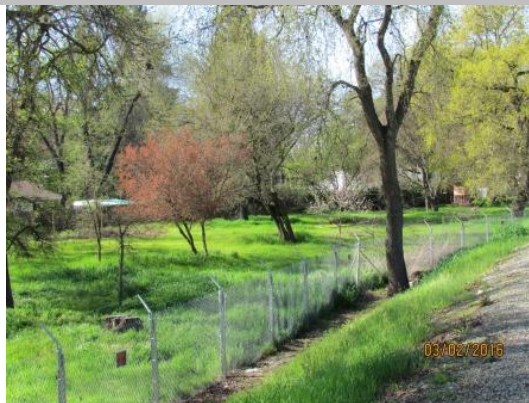
Photo 1 of 1 : SP_2019_NA0001_51_66_20190307_00043.jpg

LM Start	1.61	Rating **	M	Issue No.	66
LM End	1.68	Issue Type +	En	Location *	LS
Category	Earthen Levee			GPS Latitude/Longitude	
				Start	End
Item	Encroachments			38.627195 °	38.627500 °
				-121.440974 °	-121.439766 °
DWR ID	DWR_NA0001_01_f_2015_66				
Comment Code					
FE : Fence					
Inspector Comment					
Fence at landside levee toe.

View of the fence at the landside levee toe.

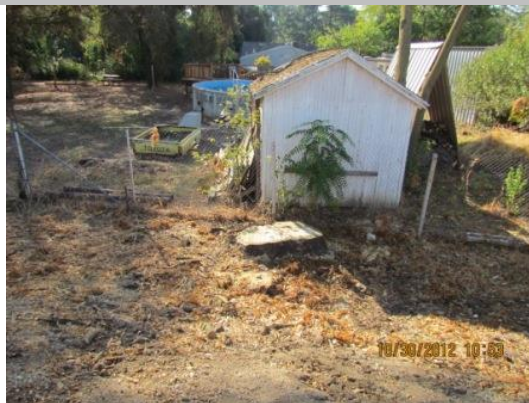
Photo 1 of 1 : SP_2019_NA0001_51_31_20190307_00025.jpg

LM Start	1.61	Rating **	N	Issue No.	31
LM End	1.61	Issue Type +	Ma	Location *	LS
Category	Earthen Levee			GPS Latitude/Longitude	
				Start	End
Item	Trim / Thin Trees			38.627191 °	38.627191 °
				-121.440861 °	-121.440861 °
DWR ID	DWR_NA0001_01_f_2012_31				
Comment Code					
T5 : Tree stumps.					
Inspector Comment

View of large tree stump at levee toe.

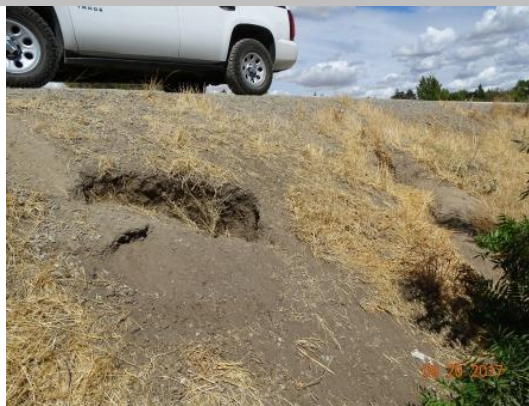
Photo 1 of 1 : SP_2019_NA0001_51_65_20190307_00042.jpg

LM Start	1.69	Rating **	A/W	Issue No.	65
LM End	1.69	Issue Type +	Ma	Location *	LS
Category	Earthen Levee			GPS Latitude/Longitude	
				Start	End
Item	Animal Control			38.627585 °	38.627585 °
				-121.439561 °	-121.439561 °
DWR ID	DWR_NA0001_01_f_2015_65				
Comment Code					
A3 : No rodents visible, but rodent burrows visible; need to backfill and compact or grout burrows.					
Inspector Comment					
The LMA backfilled the hole and is actively monitoring the area.

View of the animal activity on the levee slope.

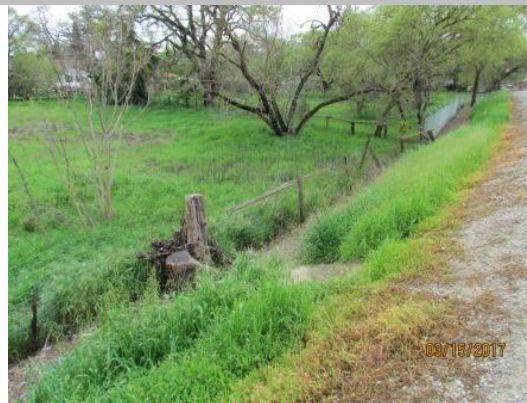
Photo 1 of 1 : SP_2019_NA0001_51_74_20190307_00048.jpg

LM Start	1.69	Rating **	N	Issue No.	74
LM End	1.69	Issue Type +	Ma	Location *	LS
Category	Earthen Levee			GPS Latitude/Longitude	
				Start	End
Item	Trim / Thin Trees			38.627607 °	38.627607 °
				-121.439545 °	-121.439545 °
DWR ID	DWR_NA0001_01_s_2017_74				
Comment Code					
T5 : Tree stumps.					
Inspector Comment					
24 inch large tree stump at levee toe.

View of the tree stump at the levee toe.

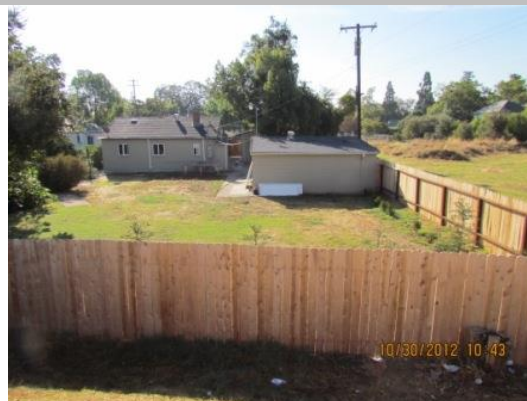
Photo 1 of 1 : SP_2019_NA0001_51_10_20190307_00009.jpg

LM Start	1.79	Rating **	U	Issue No.	10
LM End	1.79	Issue Type +	En	Location *	LS
Category	Earthen Levee			GPS Latitude/Longitude	
				Start	End
Item	Encroachments			38.627948 °	38.627948 °
				-121.437682 °	-121.437682 °
DWR ID	DWR_NA0001_01_f_2012_10				
Comment Code					
FE : Fence					
Inspector Comment					
Wooden fence constructed at LS levee toe.

View of new fence constructed at levee toe and 7 redwood trees planted behind fence within easement.

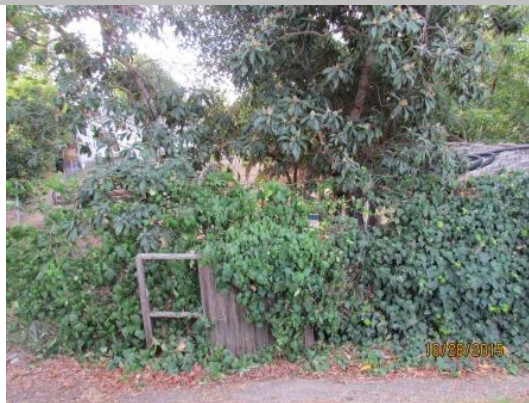
Photo 1 of 1 : SP_2019_NA0001_51_170_20190307_00054.jpg

LM Start	1.81	Rating **	U	Issue No.	170
LM End	1.81	Issue Type +	En	Location *	LS
Category	Earthen Levee			GPS Latitude/Longitude	
				Start	End
Item	Vegetation			38.627934 °	38.627934 °
				-121.437423 °	-121.437423 °
DWR ID	DWR_NA0001_01_s_2012_170				
Comment Code					
V6 : Landscaping					
Inspector Comment					
Growth on old wooden fence, which has since been replaced by a chainlink fence is obstructive.

View of the landscaping at the landside levee toe.

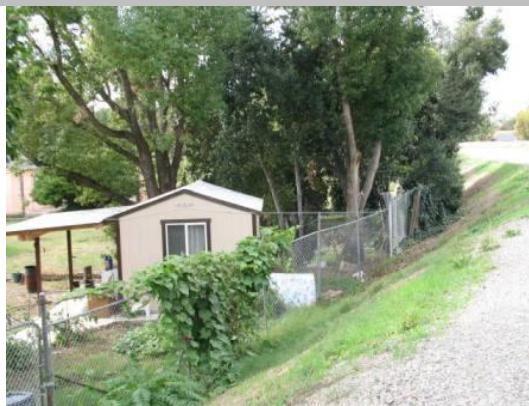
Photo 1 of 1 : SP_2019_NA0001_51_169_20190307_00053.jpg

LM Start	1.82	Rating **	U	Issue No.	169
LM End	1.82	Issue Type +	En	Location *	LS
Category	Earthen Levee			GPS Latitude/Longitude	
				Start	End
Item	Encroachments			38.627922 °	38.627922 °
				-121.437296 °	-121.437296 °
DWR ID	DWR_NA0001_01_s_2012_169				
Comment Code					
BU : Building					
Inspector Comment					
Shed on concrete pad within 10' of the levee toe.

11/17/2011 Wooden shed on concrete pad built within 15' of levee toe.

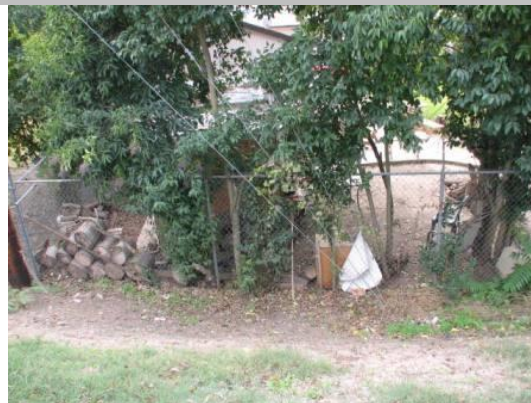
Photo 1 of 1 : SP_2019_NA0001_51_33_20190307_00026.jpg

LM Start	1.83	Rating **	U	Issue No.	33
LM End	1.83	Issue Type +	En	Location *	LS
Category	Earthen Levee			GPS Latitude/Longitude	
				Start	End
Item	Encroachments			38.627897 °	38.627897 °
				-121.437073 °	-121.437073 °
DWR ID	DWR_NA0001_01_s_2012_33				
Comment Code					
BU : Building					
Inspector Comment					
Wooden animal pen is built against levee slope.

11/17/2011 Wooden structure is built within 15' of the levee toe.

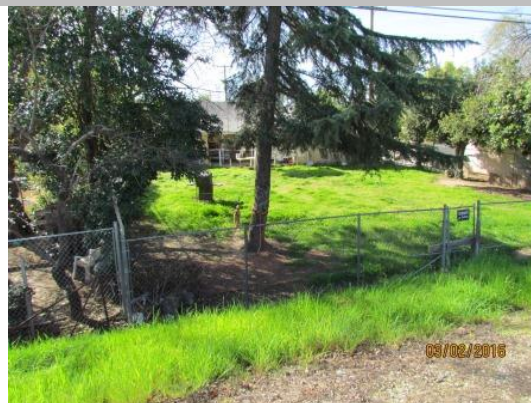
Photo 1 of 1 : SP_2019_NA0001_51_63_20190307_00041.jpg

LM Start	1.84	Rating **	M	Issue No.	63
LM End	1.84	Issue Type +	En	Location *	LS
Category	Earthen Levee			GPS Latitude/Longitude	
				Start	End
Item	Encroachments			38.627879 °	38.627879 °
				-121.436889 °	-121.436889 °
DWR ID	DWR_NA0001_01_f_2015_63				
Comment Code					
FE : Fence					
Inspector Comment					
Fence at landside levee toe.

View of the fence at the landside levee toe.

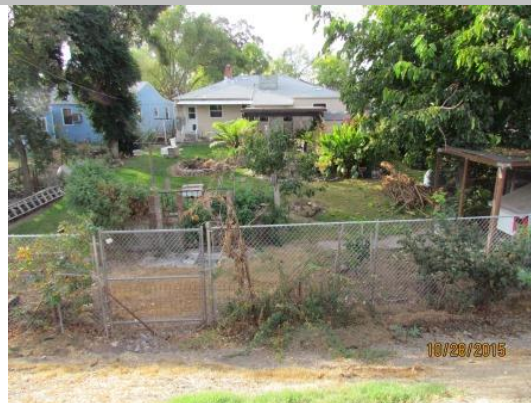
Photo 1 of 1 : SP_2019_NA0001_51_9_20190307_00008.jpg

LM Start	1.85	Rating **	M	Issue No.	9
LM End	1.85	Issue Type +	En	Location *	LS
Category	Earthen Levee			GPS Latitude/Longitude	
				Start	End
Item	Encroachments			38.627884 °	38.627884 °
				-121.436682 °	-121.436682 °
DWR ID	DWR_NA0001_01_s_2012_9				
Comment Code					
FE : Fence					
Inspector Comment

View of the fence at the landside levee toe.

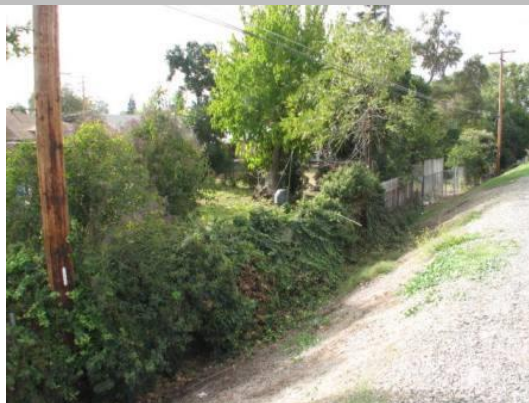
Photo 1 of 1 : SP_2019_NA0001_51_8_20190307_00007.jpg

LM Start	1.85	Rating **	M	Issue No.	8
LM End	1.85	Issue Type +	En	Location *	LS
Category	Earthen Levee			GPS Latitude/Longitude	
				Start	End
Item	Vegetation			38.627889 °	38.627889 °
				-121.436638 °	-121.436638 °
DWR ID	DWR_NA0001_01_s_2012_8				
Comment Code					
V6 : Landscaping					
Inspector Comment					
Ivy, trees and other landscaping growing on a privacy fence are obstructing visibility.

11/17/2011 Landscaping vegetation growth on the fence is obstructive.

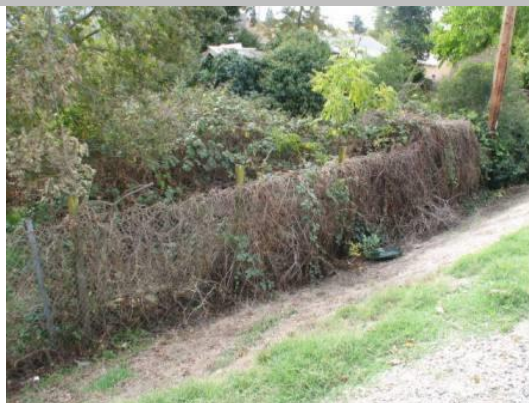
Photo 1 of 1 : SP_2019_NA0001_51_7_20190307_00006.jpg

LM Start	1.86	Rating **	U	Issue No.	7
LM End	1.86	Issue Type +	En	Location *	LS
Category	Earthen Levee			GPS Latitude/Longitude	
				Start	End
Item	Vegetation			38.627889 °	38.627889 °
				-121.436454 °	-121.436454 °
DWR ID	DWR_NA0001_01_s_2012_7				
Comment Code					
V6 : Landscaping					
Inspector Comment					
Metal sided shelter, blackberries and cherry trees are obstructive.

11/17/2011 Blackberries growing on fence are obstructive.

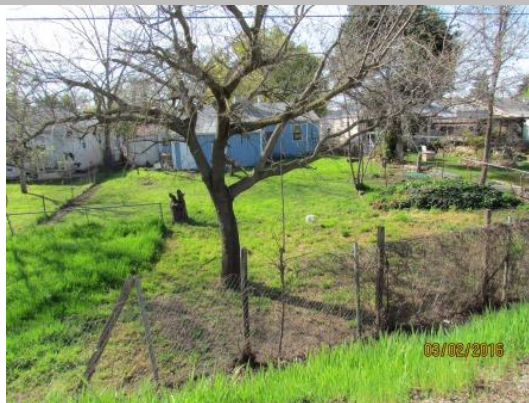
Photo 1 of 1 : SP_2019_NA0001_51_61_20190307_00040.jpg

LM Start	1.86	Rating **	M	Issue No.	61
LM End	1.86	Issue Type +	En	Location *	LS
Category	Earthen Levee			GPS Latitude/Longitude	
				Start	End
Item	Encroachments			38.627885 °	38.627885 °
				-121.436423 °	-121.436423 °
DWR ID	DWR_NA0001_01_f_2015_61				
Comment Code					
FE : Fence					
Inspector Comment					
Fence at landside levee toe.

View of the fence at the landside levee toe.

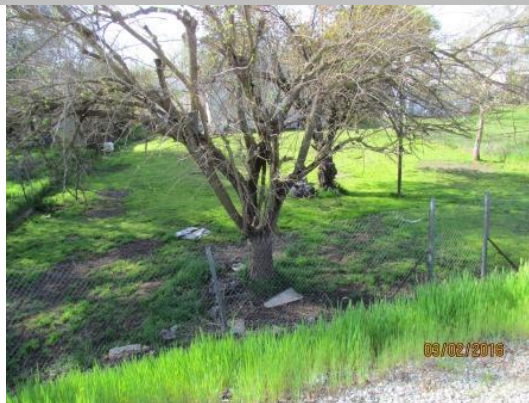
Photo 1 of 1 : SP_2019_NA0001_51_59_20190307_00039.jpg

LM Start	1.88	Rating **	M	Issue No.	59
LM End	1.88	Issue Type +	En	Location *	LS
Category	Earthen Levee			GPS Latitude/Longitude	
				Start	End
Item	Encroachments			38.627871 °	38.627871 °
				-121.436191 °	-121.436191 °
DWR ID	DWR_NA0001_01_f_2015_59				
Comment Code					
FE : Fence					
Inspector Comment					
Fence at landside levee toe.

View of the fence at the landside levee toe.

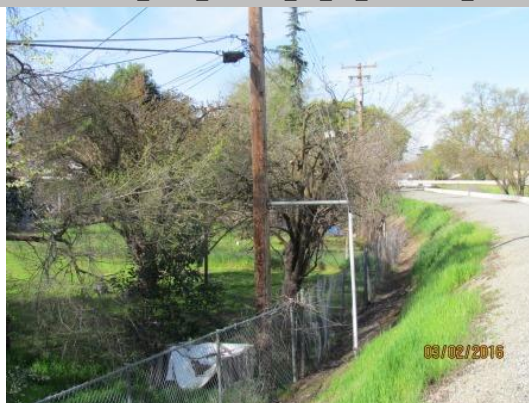
Photo 1 of 1 : SP_2019_NA0001_51_58_20190307_00038.jpg

LM Start	1.88	Rating **	M	Issue No.	58
LM End	1.88	Issue Type +	En	Location *	LS
Category	Earthen Levee			GPS Latitude/Longitude	
				Start	End
Item	Encroachments			38.627860 °	38.627860 °
				-121.436098 °	-121.436098 °
DWR ID	DWR_NA0001_01_f_2015_58				
Comment Code					
PO : Pole					
Inspector Comment					
Pole at the landside levee toe with guy wire penetrating the landside levee slope.

View of the pole at the landside levee toe.

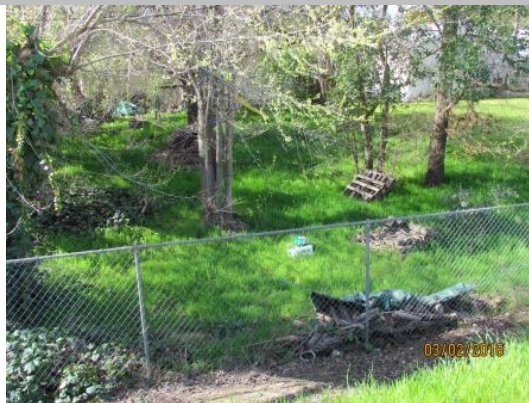
Photo 1 of 1 : SP_2019_NA0001_51_57_20190307_00037.jpg

LM Start	1.89	Rating **	M	Issue No.	57
LM End	1.89	Issue Type +	En	Location *	LS
Category	Earthen Levee			GPS Latitude/Longitude	
				Start	End
Item	Encroachments			38.627837 °	38.627837 °
				-121.435973 °	-121.435973 °
DWR ID	DWR_NA0001_01_f_2015_57				
Comment Code					
FE : Fence					
Inspector Comment					
Fence at landside levee toe.

View of the fence at the landside levee toe.

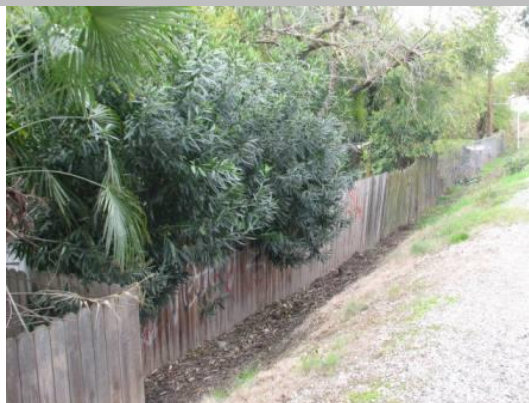
Photo 1 of 1 : SP_2019_NA0001_51_6_20190307_00005.jpg

LM Start	1.90	Rating **	U	Issue No.	6
LM End	1.90	Issue Type +	En	Location *	LS
Category	Earthen Levee			GPS Latitude/Longitude	
				Start	End
Item	Encroachments			38.627725 °	38.627725 °
				-121.435715 °	-121.435715 °
DWR ID	DWR_NA0001_01_s_2012_6				
Comment Code					
FE : Fence					
Inspector Comment					
Dog-eared wooden fence is built within 10-ft of the levee slope.

11/17/2011 Wooden privacy fence built at the levee toe.

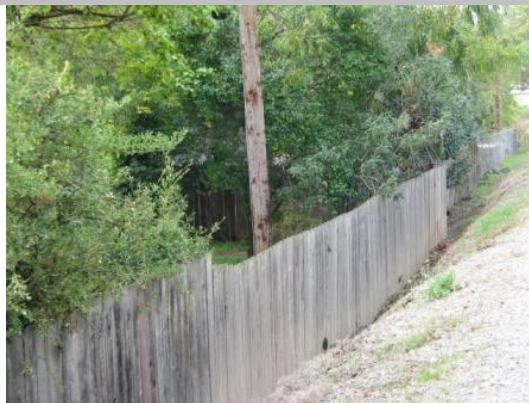
Photo 1 of 1 : SP_2019_NA0001_51_5_20190307_00004.jpg

LM Start	1.91	Rating **	U	Issue No.	5
LM End	1.91	Issue Type +	En	Location *	LS
Category	Earthen Levee			GPS Latitude/Longitude	
				Start	End
Item	Encroachments			38.627680 °	38.627680 °
				-121.435555 °	-121.435555 °
DWR ID	DWR_NA0001_01_s_2012_5				
Comment Code					
FE : Fence					
Inspector Comment					
Dog-eared wooden fence is built against the levee slope.

11/17/2011 Wooden privacy fence built at the levee toe.

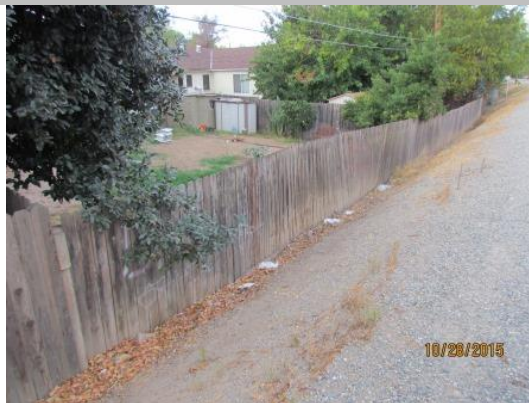
Photo 1 of 1 : SP_2019_NA0001_51_4_20190307_00003.jpg

LM Start	1.92	Rating **	U	Issue No.	4
LM End	1.92	Issue Type +	En	Location *	LS
Category	Earthen Levee			GPS Latitude/Longitude	
				Start	End
Item	Encroachments			38.627715 °	38.627715 °
				-121.435452 °	-121.435452 °
DWR ID	DWR_NA0001_01_s _ 2012_4				
Comment Code					
FE : Fence					
Inspector Comment					
Wooden fence and landscaping completely block visibility.

View of the wooden fence at the landside levee toe.

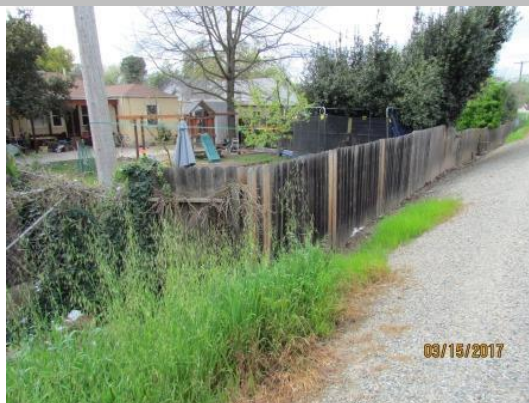
Photo 1 of 1 : SP_2019_NA0001_51_3_20190307_00002.jpg

LM Start	1.93	Rating **	U	Issue No.	3
LM End	1.93	Issue Type +	En	Location *	LS
Category	Earthen Levee			GPS Latitude/Longitude	
				Start	End
Item	Encroachments			38.627658 °	38.627658 °
				-121.435192 °	-121.435192 °
DWR ID	DWR_NA0001_01_s _ 2012_3				
Comment Code					
FE : Fence					
Inspector Comment					
Dog-eared wooden fence is built against the levee slope.

View of the fence at the landside levee toe. Spring 2017

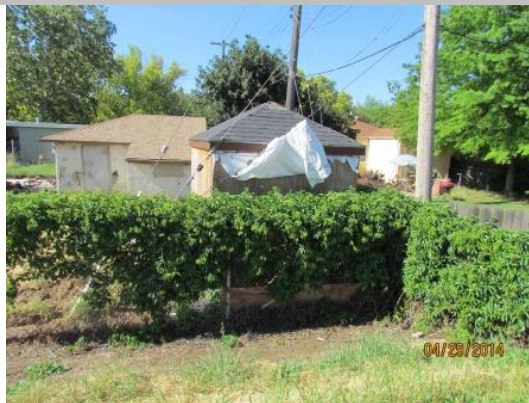
Photo 1 of 1 : SP_2019_NA0001_51_30_20190307_00024.jpg

LM Start	1.93	Rating **	U	Issue No.	30
LM End	1.93	Issue Type +	En	Location *	LS
Category	Earthen Levee			GPS Latitude/Longitude	
				Start	End
Item	Encroachments			38.627646 °	38.627646 °
				-121.435151 °	-121.435151 °
DWR ID	DWR_NA0001_01_s _ 2019_30				
Comment Code					
BU : Building					
Inspector Comment					
Wooden frame structure is within 15-ft of levee toe.

Building on concrete pad within 15 feet of the landside levee toe.

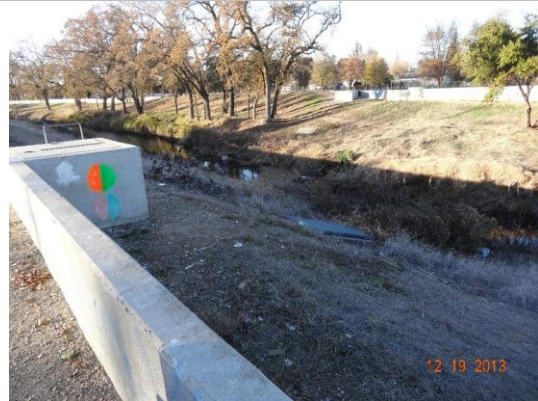
Photo 1 of 3 : UCIP_SP_2019_41549_57087.jpg

01/29/14 approximate alignment of crossings was provided by the City of Sacramento for known crossings through levee. Unable to confirm last inspection. Also City records indicate 10-inch not 15-inch--need to clarify with owner. Crossing is operational. (DWR UCIP - O. Magana)
FIELD_STRUCT_DESC: 15-inch drainage pipe of unknown material through the levee, 8.5 feet below the crown. Flap gate is located on the waterside (WS) end. (no permit has been identified authorizing this structure, structure is owned by the City of Sacramento) [Additional Reference(s): DWR Levee Log, 2002]
FS Date: 12/19/2013

View of waterward side--concrete vault and u-shape concrete headwall with debris screen.

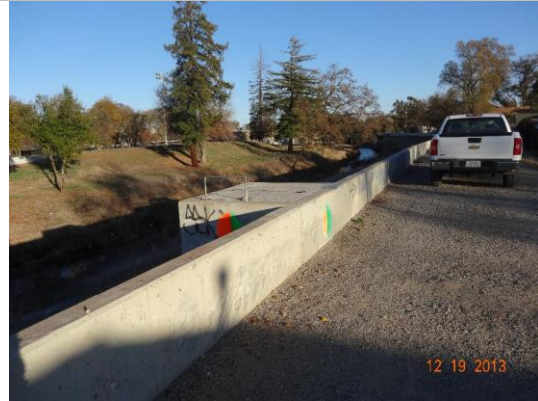
Photo 2 of 3 : UCIP_SP_2019_41549_57086.jpg

View of floodwall along waterward side.
